# **Green Roof Performance Study**

## **Seattle Public Utilities**

**June 2012**

Cardno TEC, Inc.  
2825 Eastlake Avenue East, Suite 300  
Seattle, Washington 98102

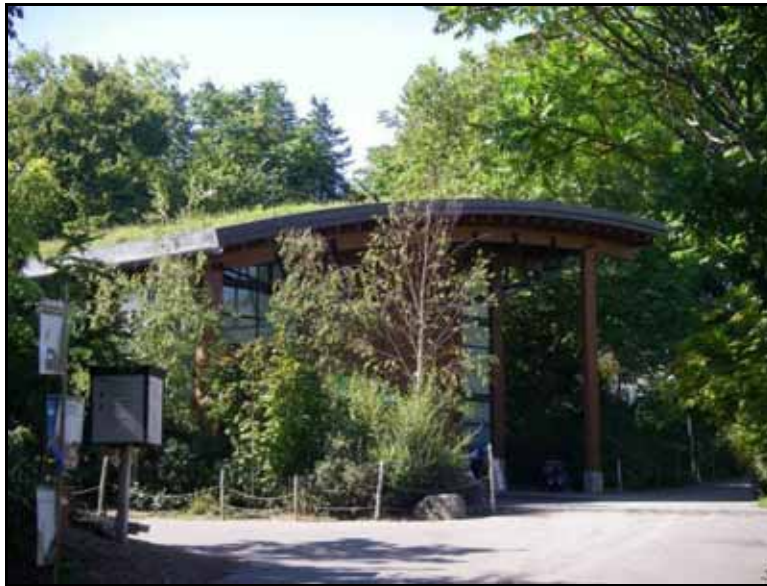
**Figure 2-1 Green Roof on the Zoomazium at the Woodland Park Zoo**

Soil depth, soil composition and vegetation for the Zoomazium green roof are provided in Table 2-1 and the implementation plan (Appendix A). It should also be noted that all green roof runoff is captured and conveyed off the green roof via one galvanized gutter. This gutter runs the length of the roof's eastern edge (Figure 2-1 and Figure 2-2).

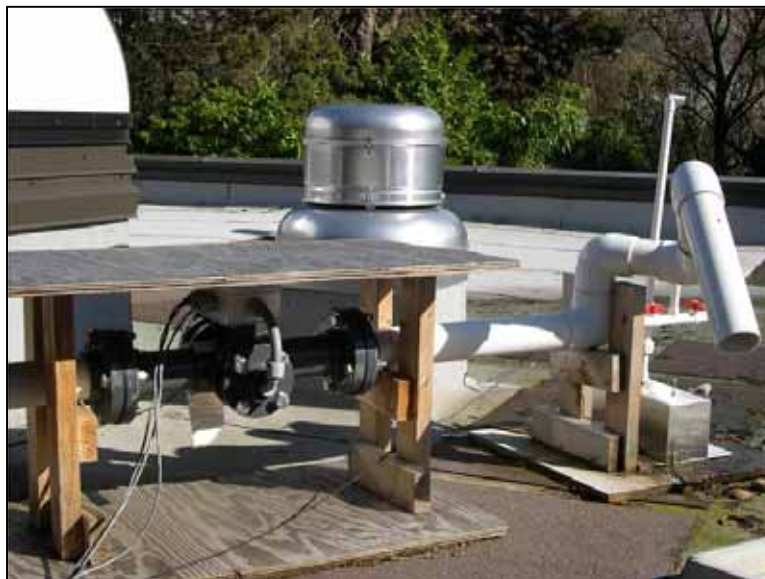
The magmeter (Figure 2-3) installed to measure higher flow rates has diminishing accuracy as flow rates drop beneath 1.5 gallons per minute (gpm) which is why a tipping bucket (Figure 2-4) was added to the monitoring system. The tipping bucket is designed by the manufacturer to measure flow rates up to 2.0 gpm. However, prior to installation while testing and calibrating the instrument, Cardno TEC staff noted the tipping bucket did not tip at the expected rate as the flow approached 2.0 gpm. A decision was made to develop a calibration curve by recording the number of tips per minute at several different flow rates. This allowed for the development of a tips/minute to flow rate relationship. The tipping bucket calibration curve developed by Cardno TEC is included in the implementation plan (Appendix A). The installed monitoring station measured runoff as it passed through the magmeter, into the tipping bucket and onto the conventional roof.

**Figure 2-3     Three Inch Unimag DP03ECTERPAA Dual Sensor  
Electromagnetic Flow Meter**

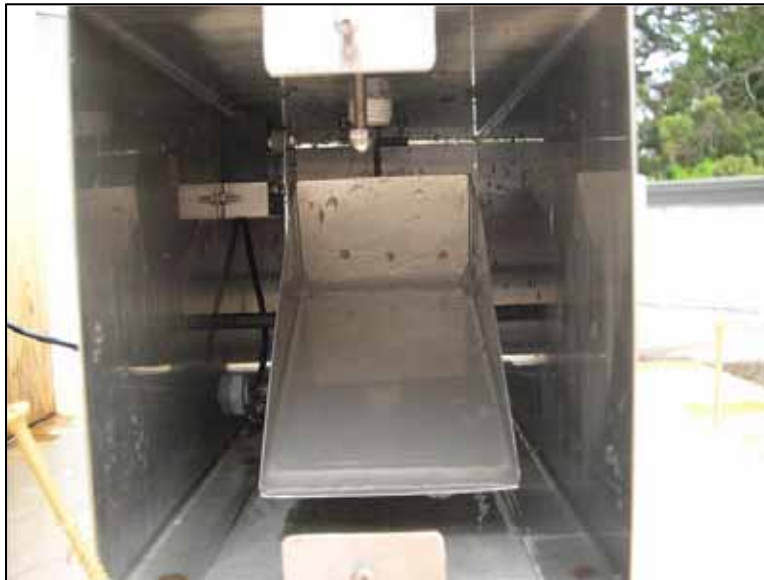
**Figure 2-4 Unidata 6506H Tipping Bucket Flow Meter**

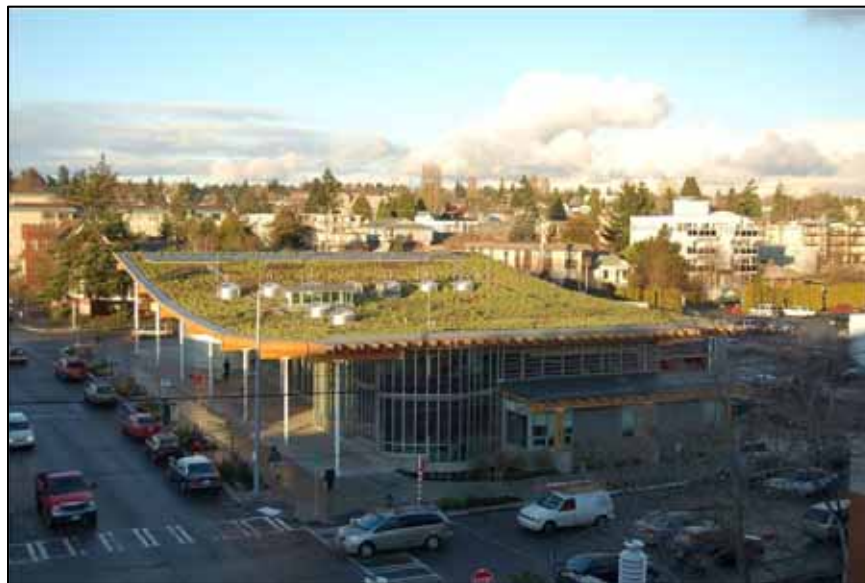
The Seattle Public Libraries' Ballard Branch (Figure 2-6) was the second roof to come on-line for the study and is located in Seattle's Ballard neighborhood at 5614 22nd Avenue Northwest. The library opened May 14, 2005, as part of the "Libraries for All" building program and was designed by Bohlin Cywinski Jackson and built by PCL Construction Services, Inc. Approximately 18,000 plants were used on the Ballard Library green roof, which covers approximately 20,000 sf. Three pairs of downspouts located in the center of the concave roof, capture runoff and redirect it to the combined sewer system. Solar panels were installed on the northern edge of the roof taking advantage of an unobstructed southern exposure. Monitoring for the Ballard Library green roof was initiated in May 2007 and completed in June 2008.

**Figure 2-6 Green Roof on the Seattle Public Library Ballard Branch**

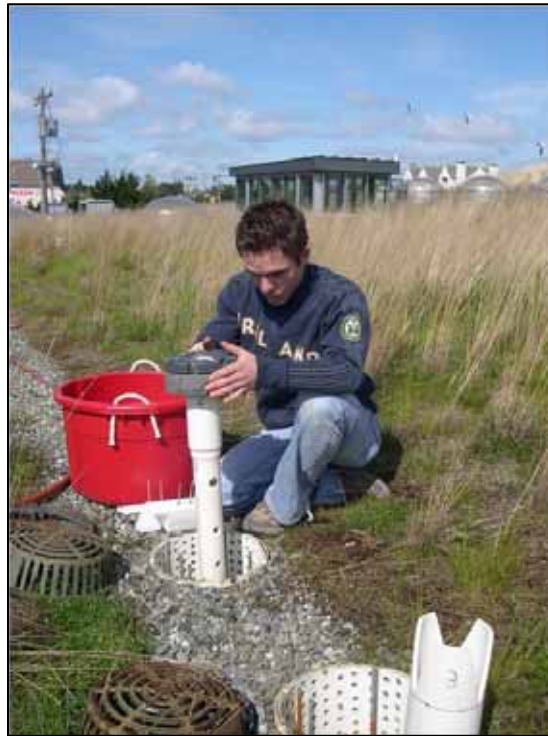
The bypass insert was constructed of PVC and to maintain drain capacity (in case of severe rain or a plugged primary drain) had a slightly larger diameter than the drain pipe. Three V-notch weirs were cut into a four-inch PVC pipe (Figure 2-8) to create a consistent flow control surface. Pressure transducers were then installed within the primary drain and behind the bypass inserts and calibrated to measure water level at the invert of the lowest orifice and v-notch weir.

**Figure 2-7      Installation of the Primary Flow Device in the Roof Drain**

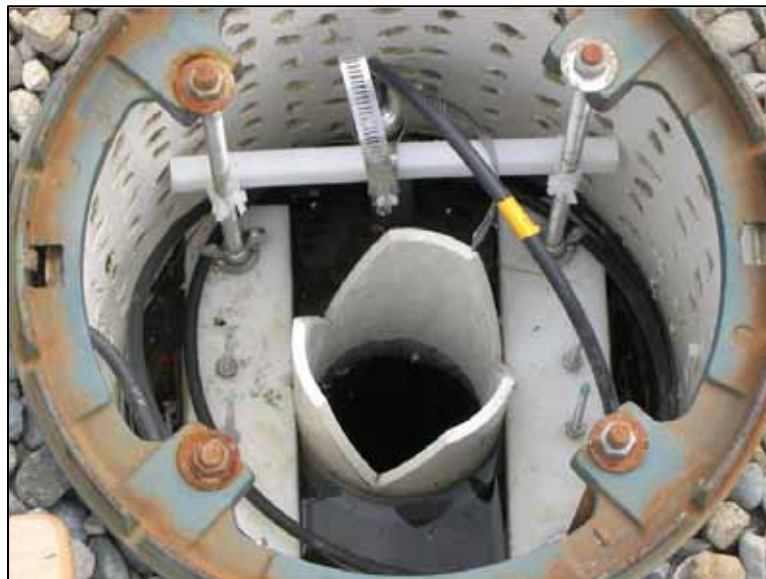
**Figure 2-8      Installation of the V-notch Weirs for Monitoring Bypass Flows in the Roof Drain**

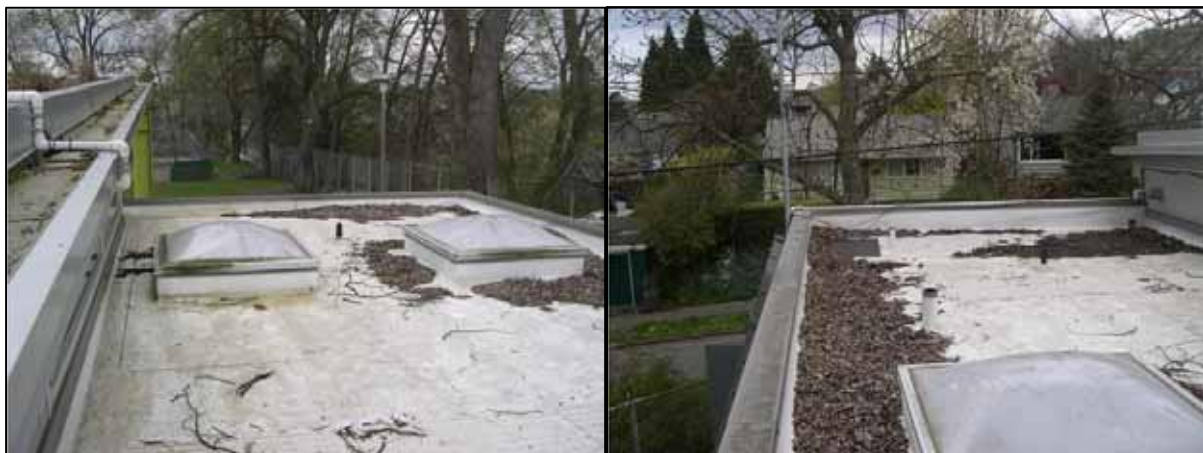
The Ross Park Shelterhouse has two separate roof sections that are parallel but at different elevations. The conventional roof (Figure 2-11) is 470 sf of flat membrane that drains to a pair of scuppers on the north side of the building. It covers the public bathrooms and is lower in elevation than the green roof by approximately five feet. The green roof (Figure 2-12) covers the eastern public use portion of the building and is approximately 876 sf. Runoff is collected in a pair of slotted drains on the north end of the green roof, where a drain pipe conveys roof runoff to the monitoring station. Soil and vegetation characteristics for the green roof are listed in the implementation plan (Appendix A) and in Table 2-1. Data collection for the Ross Park site was initiated on October 1, 2007, and continued for 12 months ending on September 20, 2008.

**Figure 2-11 Conventional Roof Located on the West Roof of the Shelterhouse**

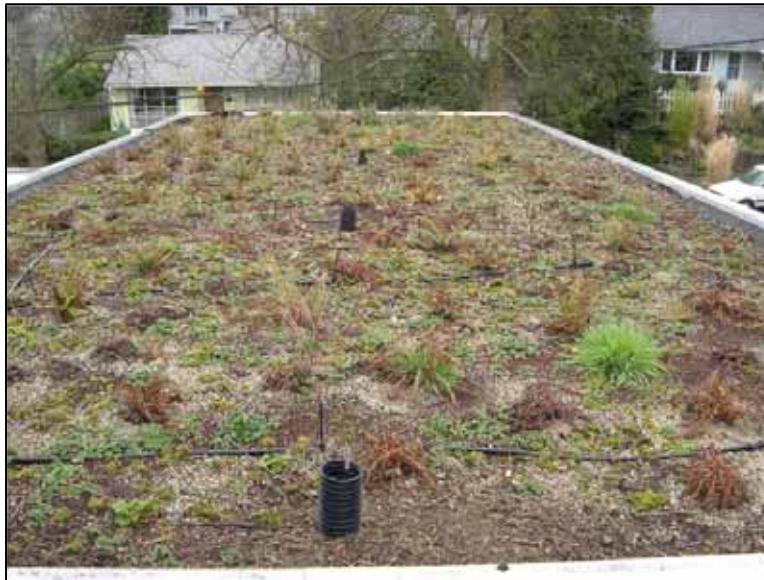
**Figure 2-12 Green Roof located on the East Roof of the Shelterhouse**

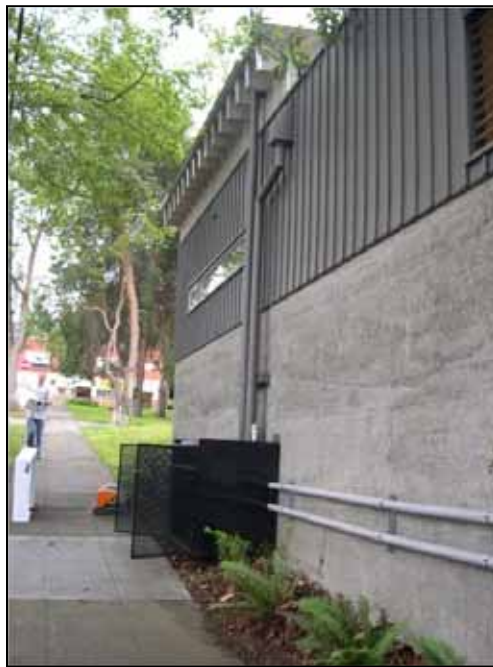
**Figure 2-13 Photo Ross Park Shelterhouse Flow Monitoring Box,  
Located on the North Side of the Building**

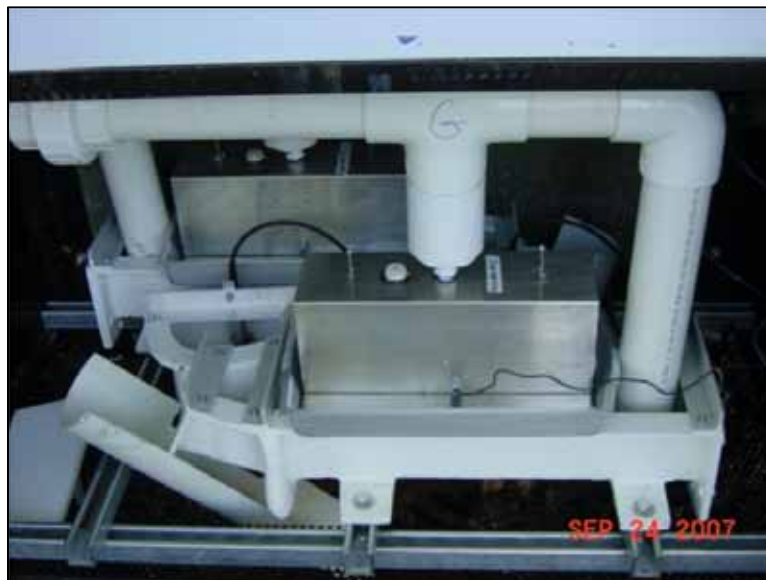
Per the manufacturer, the tipping bucket was designed to accurately measure flow rates up to 2.0 gpm; however, the same variance in accuracy at the upper design rate was found. Cardno TEC developed a rating curve by recording the number of tips per minute at several flow rates to develop a rating curve based on the observed tips-per-minute to flow rate relationship. The

**Figure 2-14 Two-Stage Flow Monitoring System  
(Tipping Bucket Coupled With HS-Flume)**

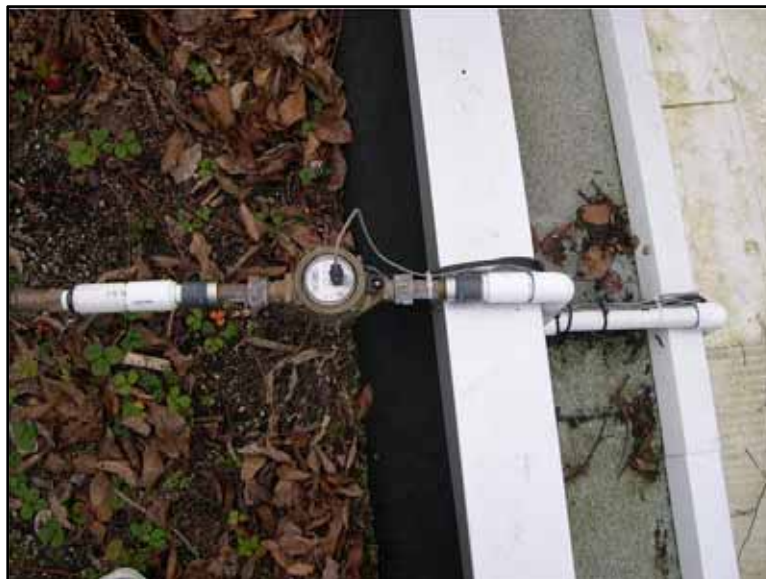
Moisture inputs from irrigation were measured with a Multijet turbine flow meter (Figure 2-15). Every gallon applied to the roof triggered an electrical pulse that was recorded by the datalogger. The meter was installed on the green roof upstream of the drip lines and typically only recorded flow during the dry season. During extended periods of freezing, it was necessary to bleed the lines so that the flow meters internal components were not damaged.

**Figure 2-15 Multijet Meter Installed for Measurement of Irrigation Water Delivered to the Ross Park Shelterhouse green roof**

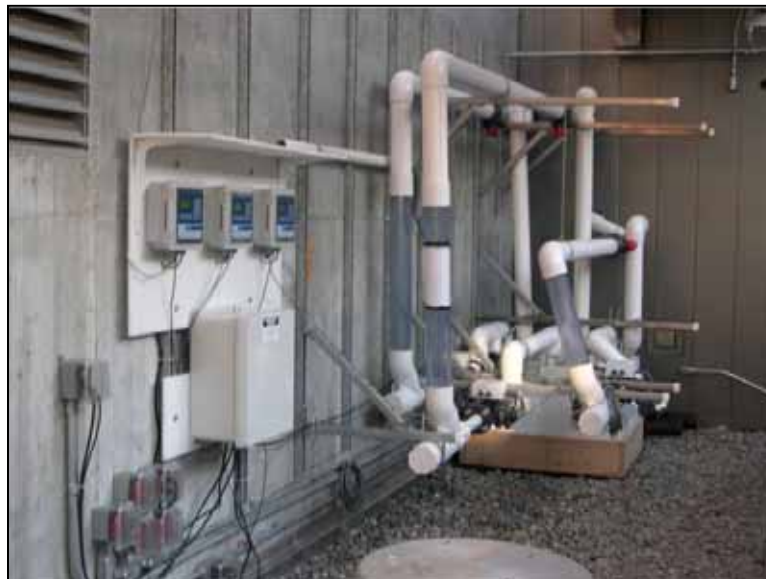
The flow monitoring station was located on northwest exterior wall of the second story of the EOC building, adjacent to the diesel generator. Runoff from the three roofs was collected in slotted drains and routed to individual rain leader pipes. Rainwater drains were deliberately plumbed to keep roof runoff isolated until it reached the monitoring station. At which point the three pipes (one from each roof) run in parallel through three independent monitoring systems. Runoff from each roof flows through a 2" Unimag magmeter to a Unidata tipping bucket (Figure 2-17). Runoff from both green roofs was captured in a HDPE tank, which recombined green roof runoff into a single rain water leader pipe. Conventional roof runoff was drained separately. Each of the three pipes had a bypass at the upstream end of the monitoring station that discharged to the plastic tank. Should a clog or malfunction occur, all flow was diverted around the monitoring equipment and into the tank.

**Figure 2-17 FS10 / EOC Flow Monitoring Station  
Located on the West Side of the EOC Building**

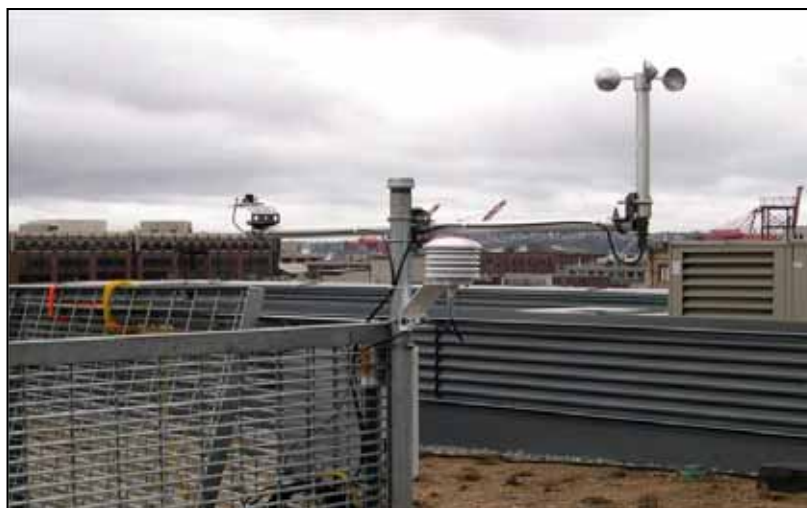
A weather station that monitored wind speed, air temperature, relative humidity, solar radiation, and precipitation was installed on the FS10 green roof. Meteorological data represents specific weather conditions for this site and are not intended to represent weather conditions beyond the FS10/EOC complex. The tipping bucket rain gauge was secured to a platform in the center of the FS10 green roof to minimize the effect of tall structures (Figure 2-18). The remaining sensors were fastened to a mast approximately 6 feet above roof level. The mast was then secured to the corner of the protective metal fencing surrounding roof vents. Precautions were made to keep sensors away from any building vents that may affect temperature or relative humidity measurements.

**Figure 2-18 Meteorological Sensors (Weather Station) Installed on the FS10 Green Roof**

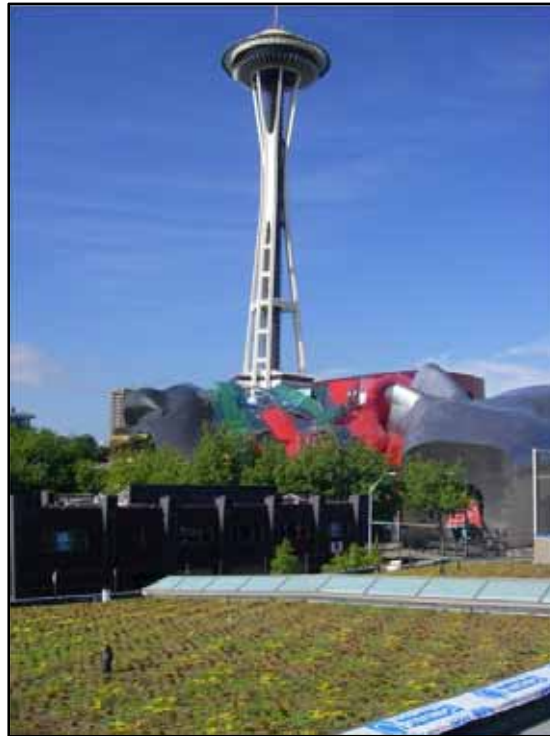
The monitoring effort at the SCPG was completed through the concept design phase; however, due to budget shortfalls the monitoring system design was never finalized nor installed. The SCPG green roof (Figure 2-19) covers nearly 1.5 acres and is located at the intersection of Harrison Street and 5th Avenue North. The structure was built through collaboration between the Bill & Melinda Gates Foundation and the Seattle Center. The parking facility was funded by the Seattle Center with funding for the green roof provided by The Bill & Melinda Gates Foundation. The roof is predominantly north facing with the southern quarter sloping to the south. The green roof design and plantings list can be found in Appendix D. Preliminary designs began in Nov 2007 and ended with partial equipment procurement in December 2008.

**Figure 2-19 Seattle City Center Parking Garage Green Roof**

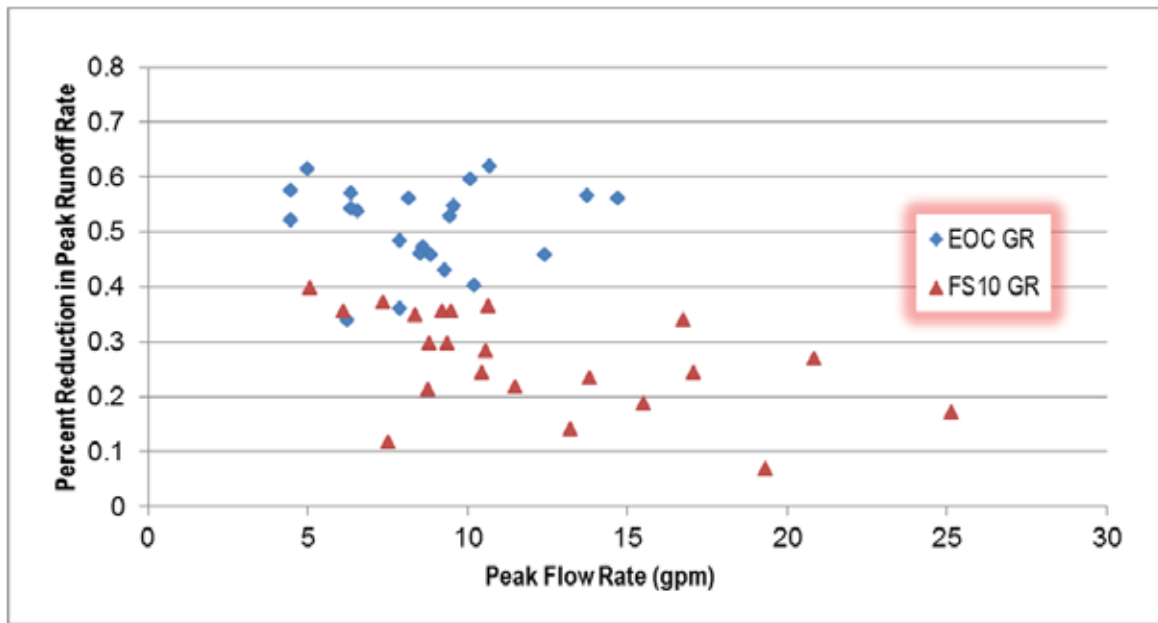
As presented in Figure 5-1 and Table 5-1 the results show significant effectiveness of the green roofs in reducing peak runoff rates. Summary peak runoff reduction data are presented in Table 5-2.

**Figure 5-1 Percent Peak Run-off Reduction for Selected Events**

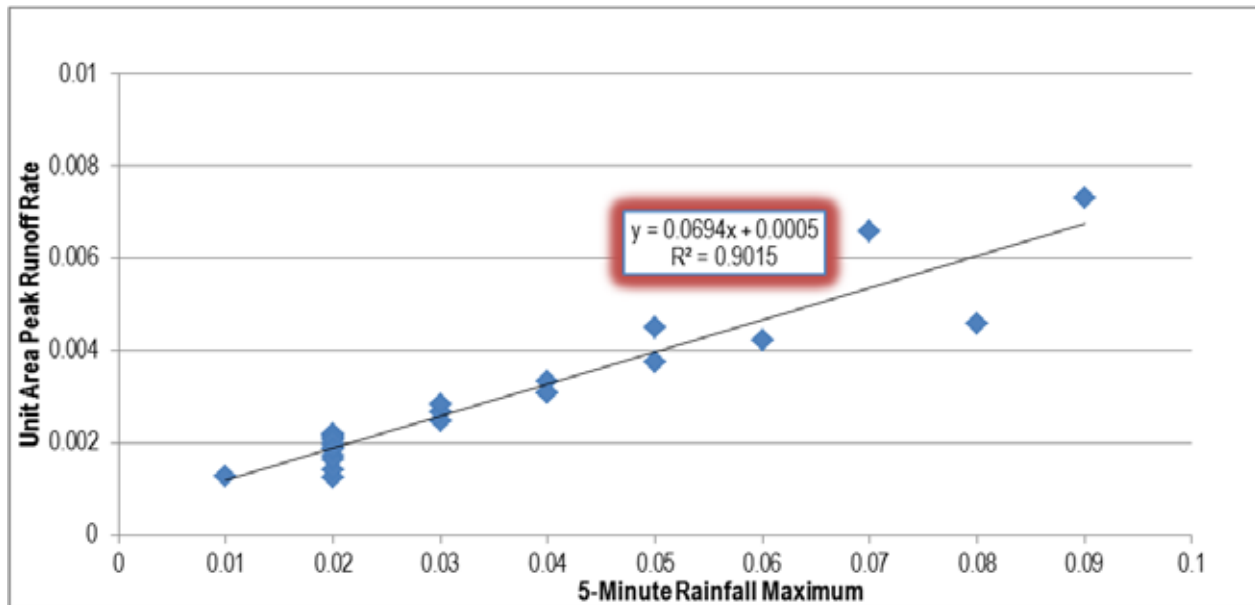
**Figure 5-2 Instantaneous Unit Area Conventional Roof  
Peak Runoff vs. Rainfall Intensity**

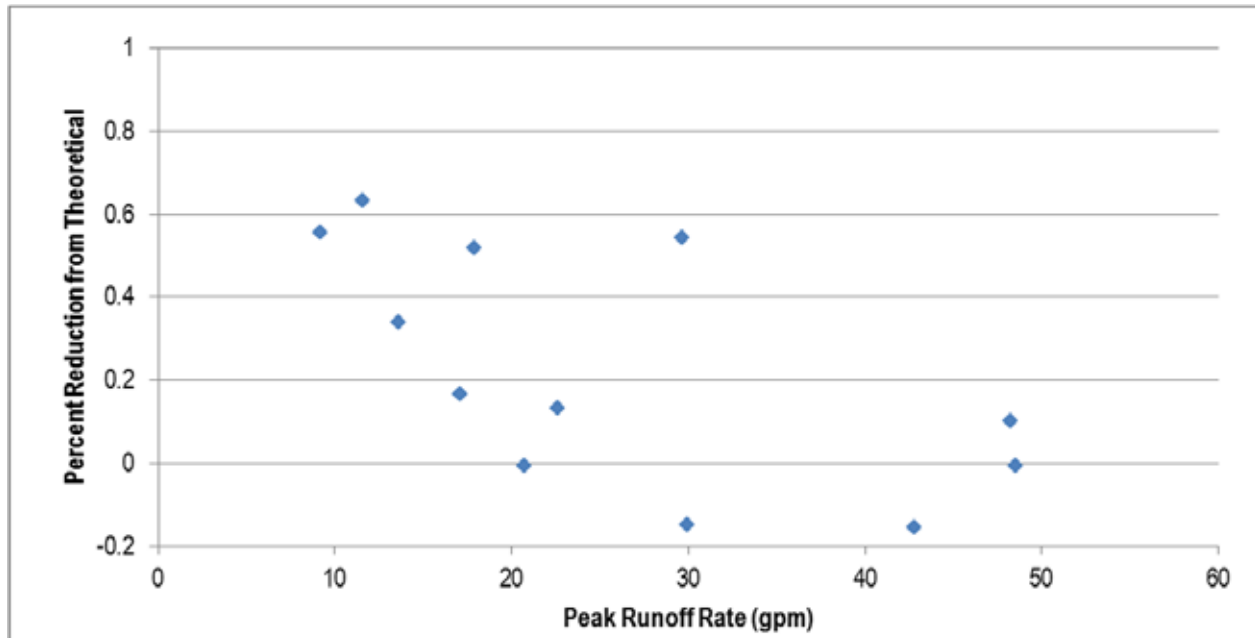
**Figure 5-3 Percent Peak Runoff Reduction for Selected Zoomazium Events**

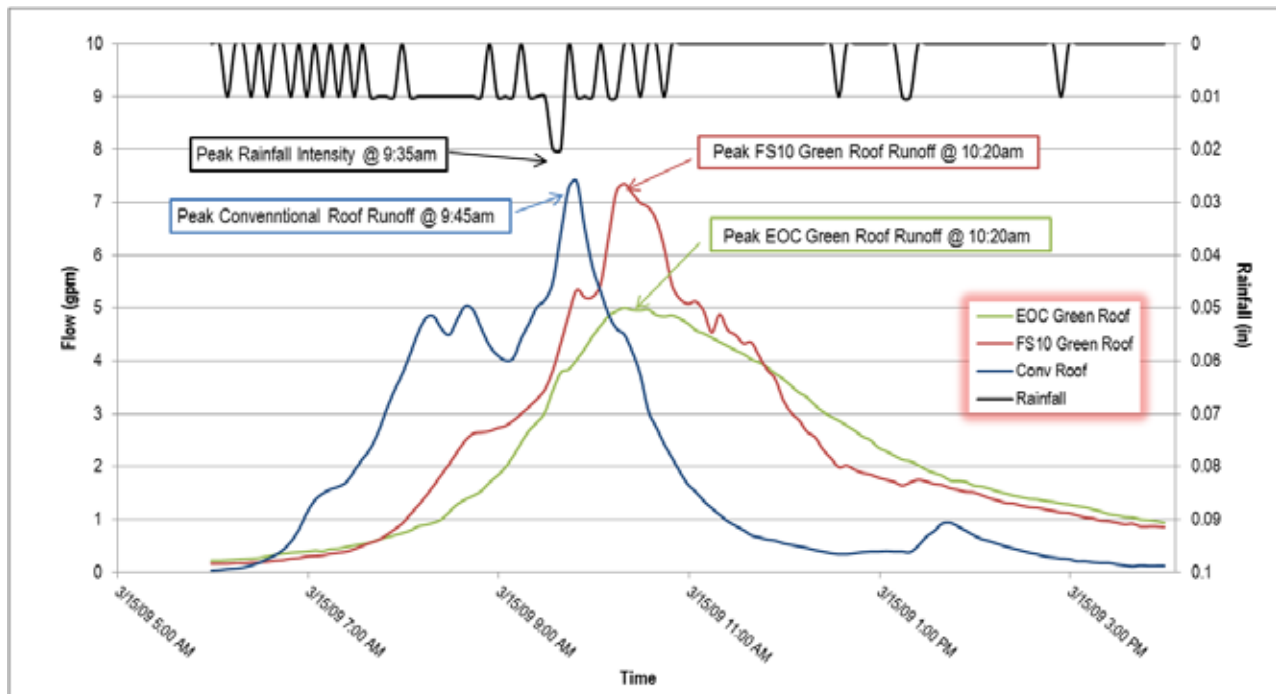
**Figure 5-4 Runoff Lag Time Comparison**

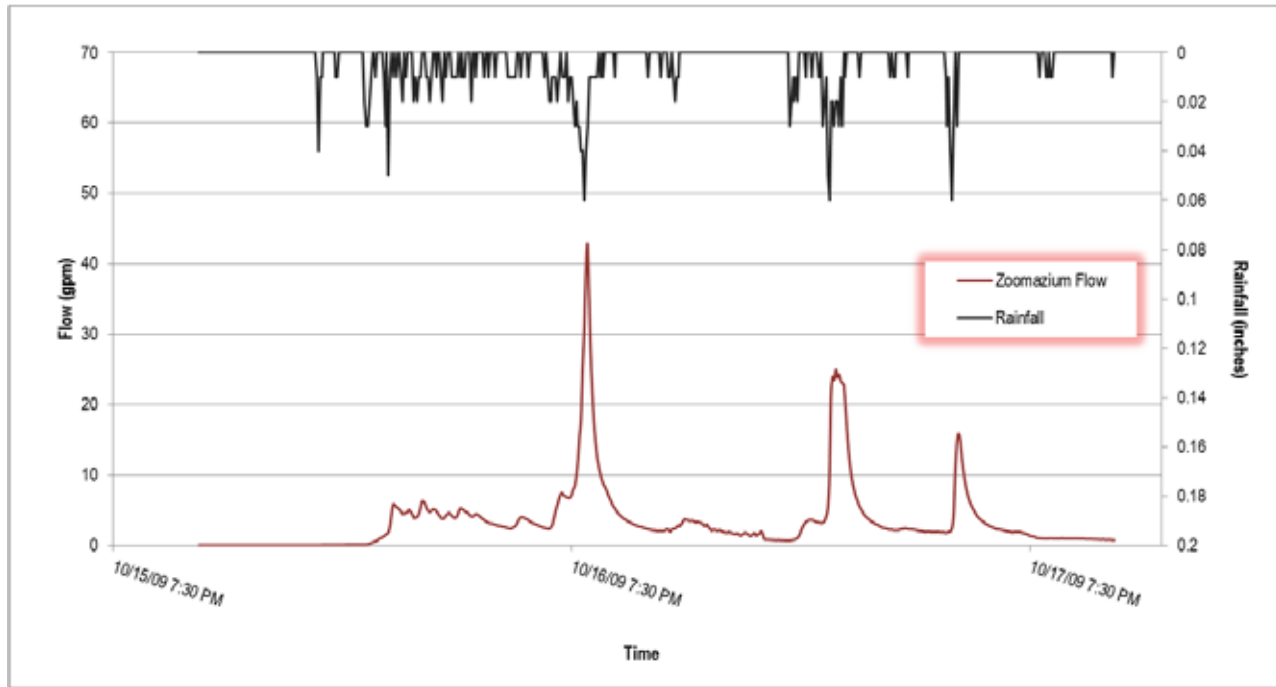
The capacity of the green roofs to reduce runoff volume and peak flow rates is significantly affected by the amount of moisture present in the soil when a rainfall event occurs. Because of the shallow soil depth on the green roofs, there is limited soil moisture storage capacity. Even during the wet season, dry periods of only a few hours preceding a storm event can result in drying of the soil and significantly affect the rainfall-runoff response of these green roofs.

**Figure 5-5 Zoomazium Rainfall-Runoff Response in Successive Events**

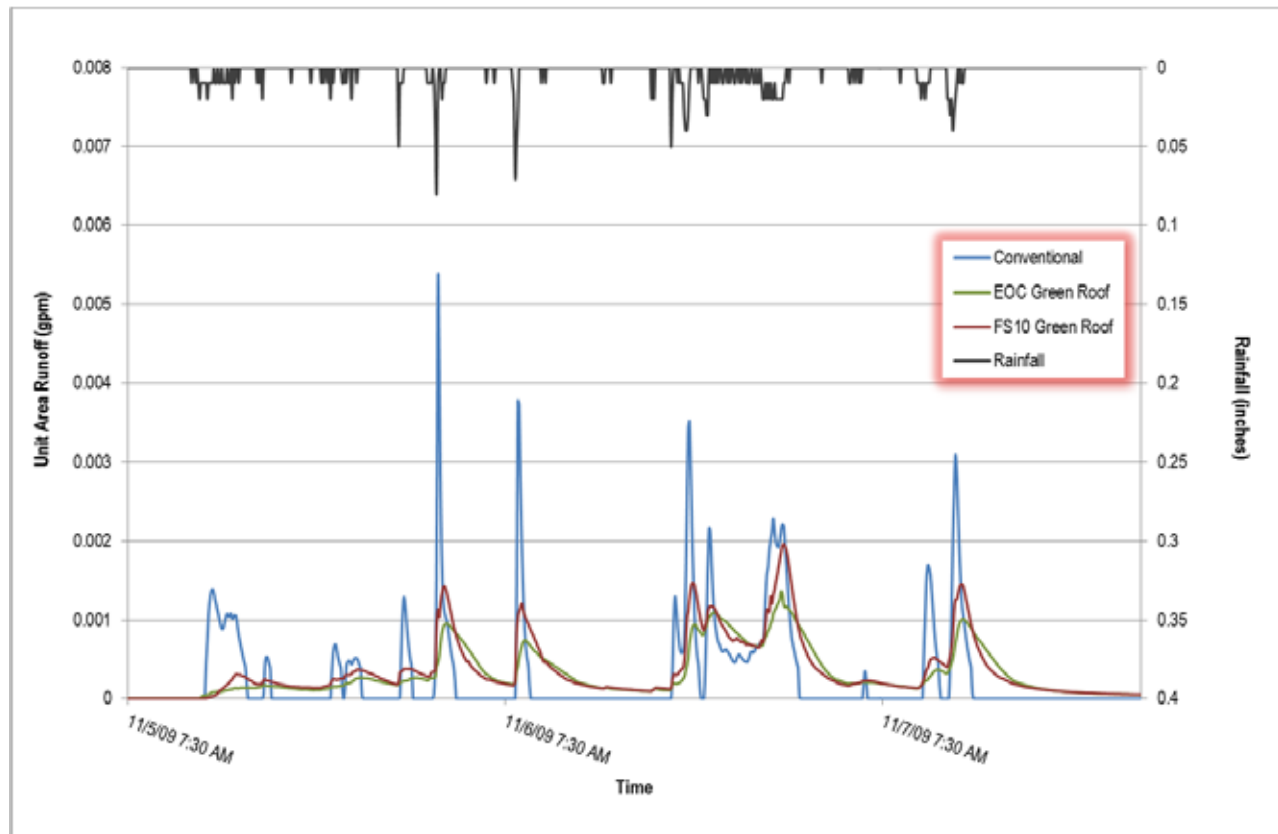
As shown in Figure 5-6, runoff from the EOC conventional roof mimics the rainfall pattern with reduced peak rates as the storm sequence progresses. However, due to the cumulative effects of both the residual soil moisture and total volume of rainfall during the later storm event, the green roof unit area runoff is higher for the lower intensity rainfall event (occurring late on November 6) than it is for the higher intensity rainfall events earlier in the storm sequence. In fact, the peak unit area runoff rate for the FS10 green roof is almost as high as for the conventional roof for this portion of the hydrograph.

**Figure 5-6 Unit Area Runoff Comparison for November 5-7, 2009**
